Multidisciplinary European Endovascular Therapy

## Diagnosis and treatment of type 3b endoleak

RG McWilliams  
Liverpool, UK

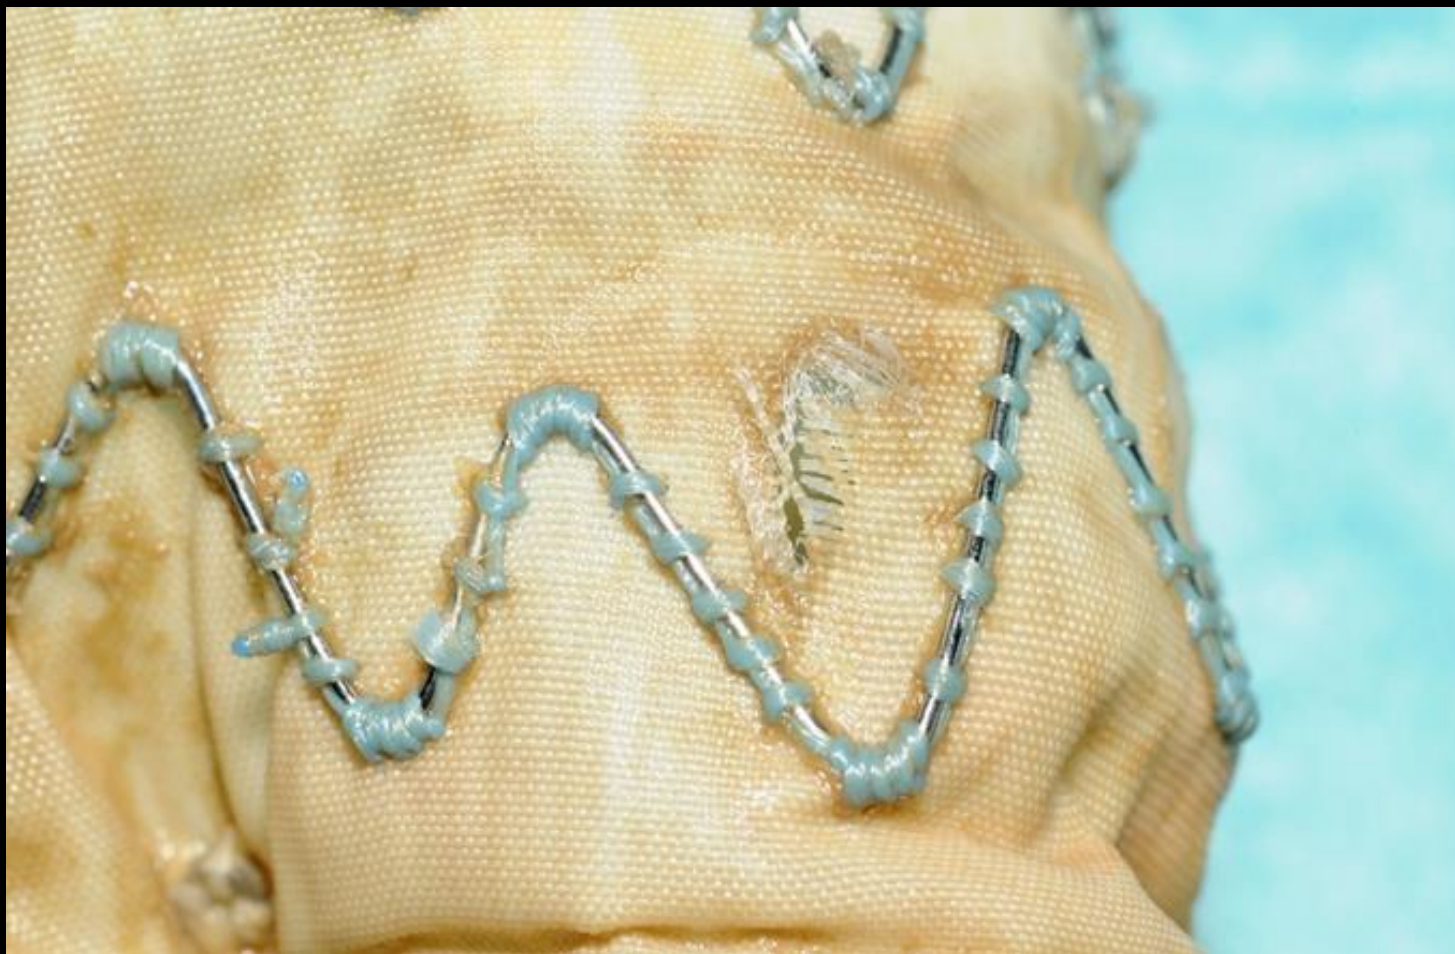
Type 3b endoleak with the Endurant graft: J Endovasc Ther. 2016 Feb;23(1):229-32

Type 3b endoleak with the Endurant graft: J Endovasc Ther. 2016 Feb;23(1):229-32
